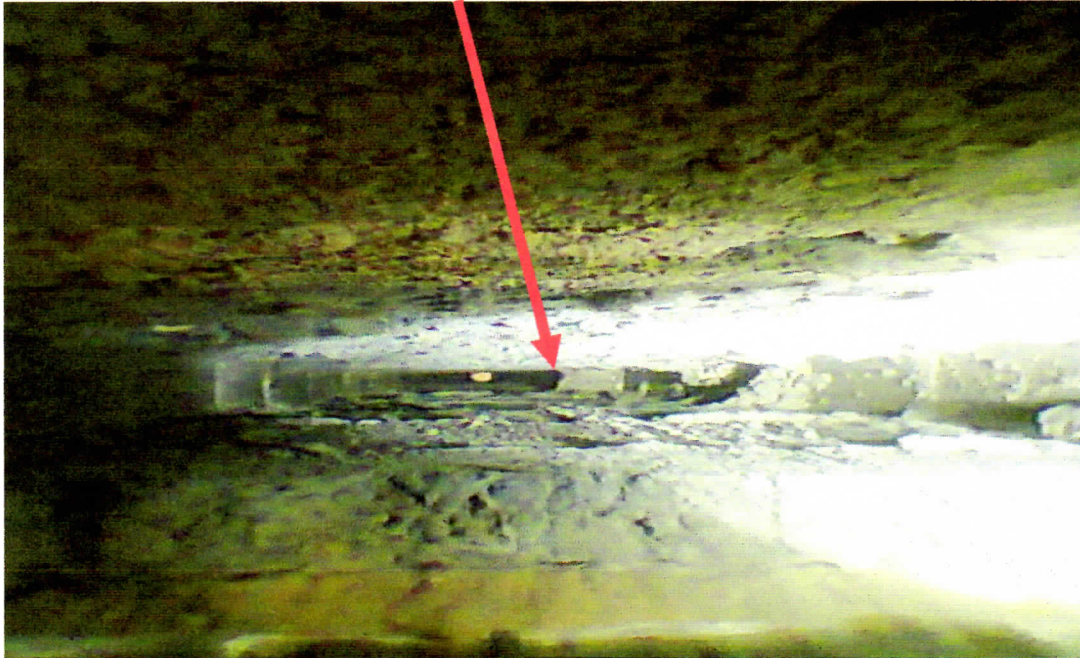
Photo of the inside of the fire wall.

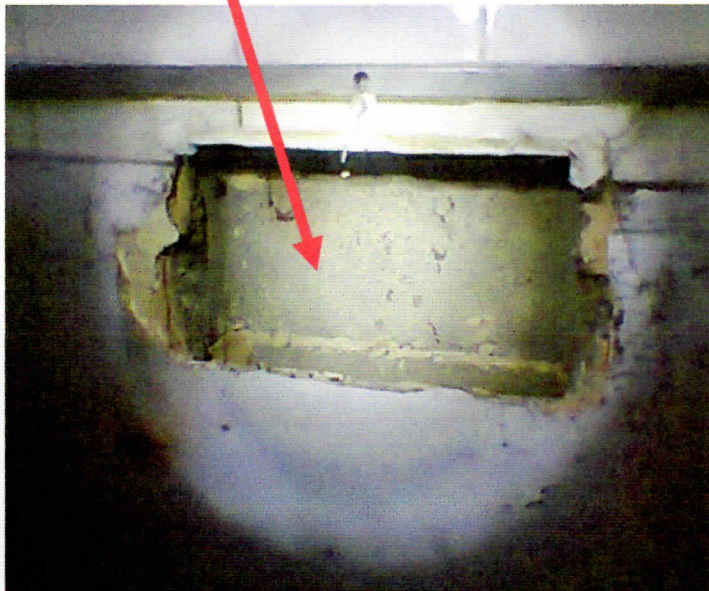
Photo of where the flue gases enter the wall, note the discolouration of the plaster wall.
